# FilterQuick™ FQGLA-T

## Gas Fryer

### Service Manual

Part Number: FRY\_SM\_8197443 02/2018

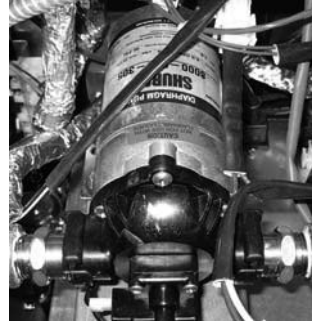
Figure 33

Disconnect the fryer from the electrical power supply. Locate the ATO pump (see Figure 33), behind the ATO box. Mark and unplug any wires or harnesses. Press down from the top on the quick disconnects to release the plumbing (see Figure 34). The plumbing can be pulled from the pump. Loosen the four nuts attaching the pump to the pump tray. Disconnect the electrical connection. Replace the defective component and reverse above steps. Once replaced, reconnect the power.

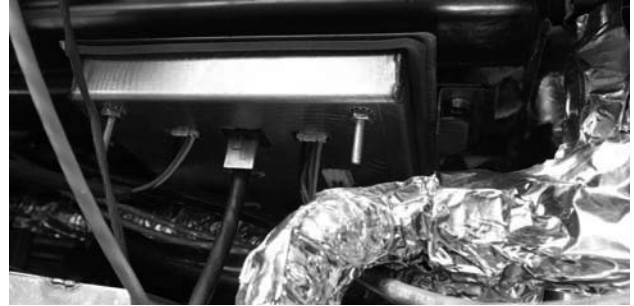
Figure 39

The VIB (Valve Interface Board) controls the actuators that open and close the drain and return valves. The VIB boards are located inside a protective housing under each frypot (see Figure 39).
