GIM4310-10 BRAKE INSTALLATION DRAWING

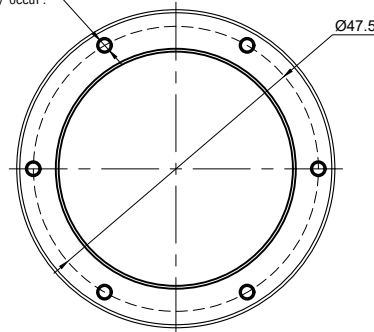
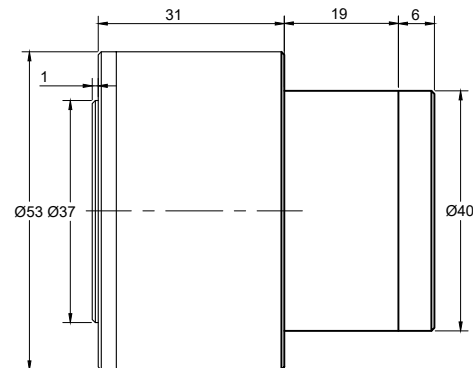
6-M2.5 THREAD DEPTH 3mm,  
Screws must not be excessively long.  
Otherwise, motor damage may occur.

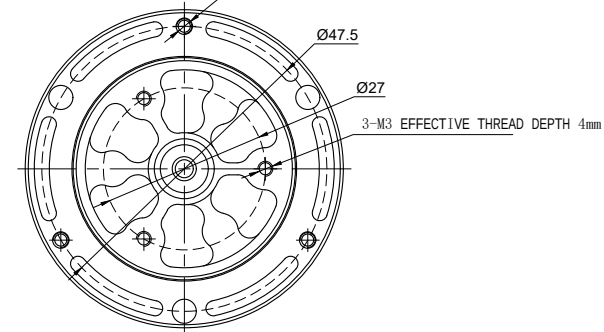
3-M2.5 EFFECTIVE THREAD DEPTH 5mm

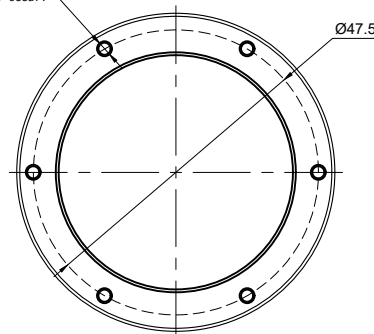
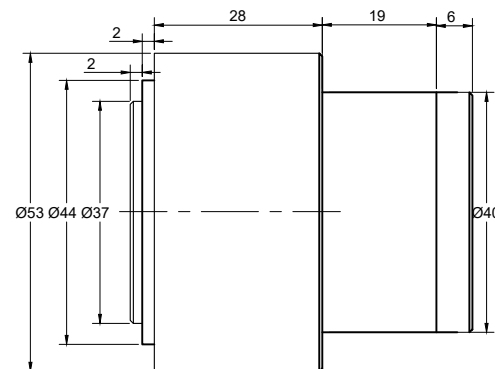
6-M2.5 THREAD DEPTH 3mm,  
Screws must not be excessively long.  
Otherwise, motor damage may occur.

FRONT COVER OMITTED

The front cover functions to constrain the bearing. The no-front-cover state applies when the motor mounting position can constrain the bearing, used to reduce installation height. This state is an unfinished structure before installation is completed. Do not test run the motor, otherwise there is danger of the rotor coming out.

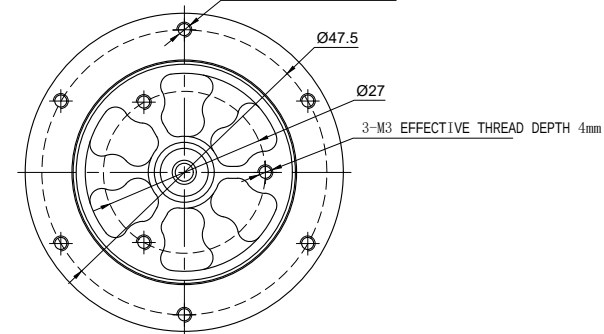
6-M2.5 EFFECTIVE THREAD DEPTH 5mm
