**AUTOMOTIVE TAIL
LIGHT ASSEMBLIES**

MODEL: 03SDHB/99SDBK/02SSBK

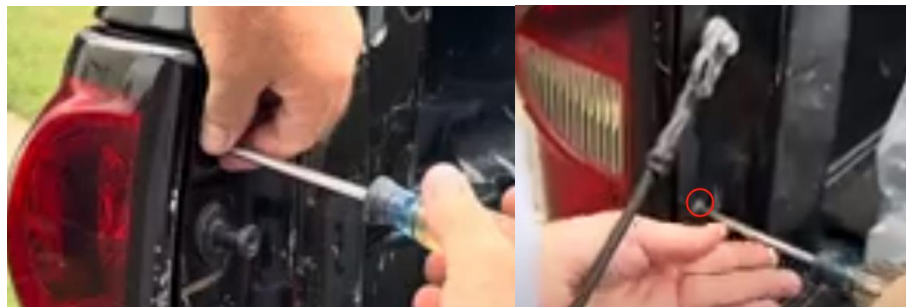
1.Open the tailgate ,remove2 Phillips screws

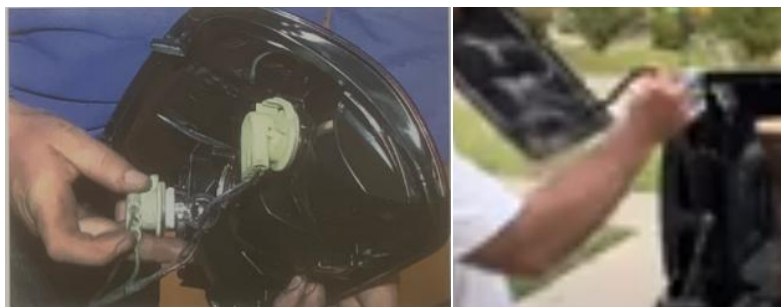
2.Remove the original factory taillight assembly, and all taillight sockets and bulbs(Note: The original reversing lights need to be retained and installed on the new lights).

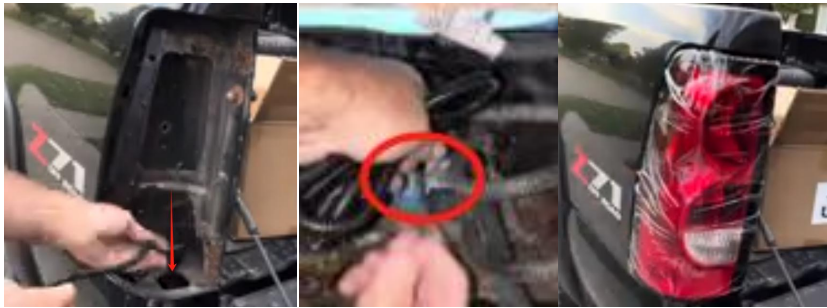
1.Locate taillight assembly, connect taillight harness and set taillight assembly in place.

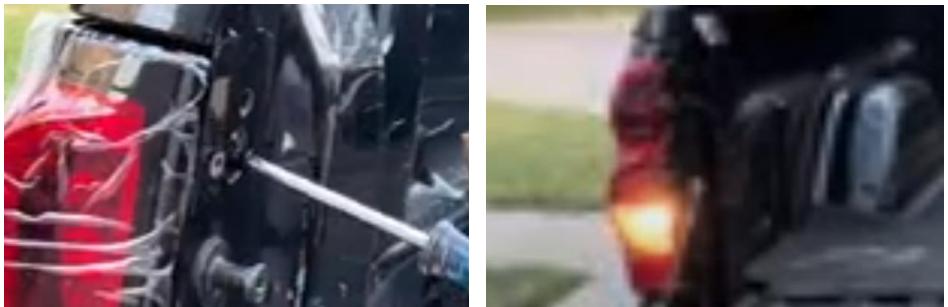
2.Reinstall 2 Phillips screws and test our light make sure everything works as it should.

※The above figure shows the replacement of only one of the models, the operation process is similar for other models.
