**AUTOMOTIVE TAIL  
LIGHT ASSEMBLIES**

**MODEL: 03SDHB/99SDBK/02SSBK**

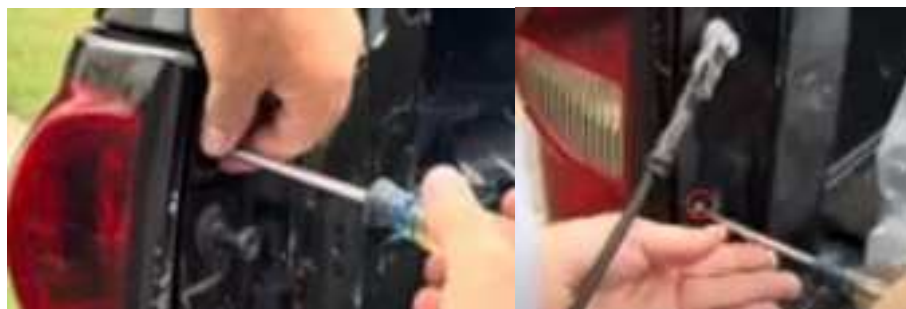
1.Open the tailgate ,remove2 Phillips screws

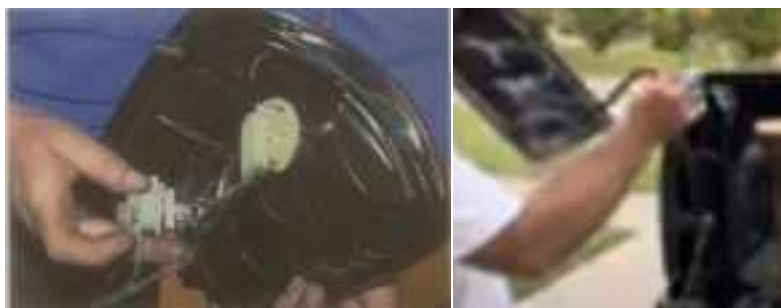
2.Remove the original factory taillight assembly, and all taillight sockets and bulbs(Note: The original reversing lights need to be retained and installed on the new lights).

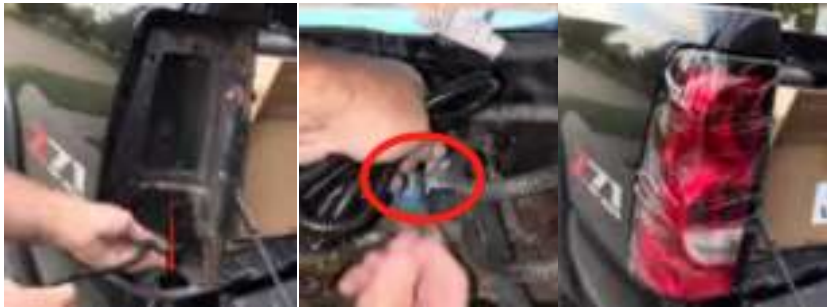
1.Locate taillight assembly, connect taillight harness and set taillight assembly in place.

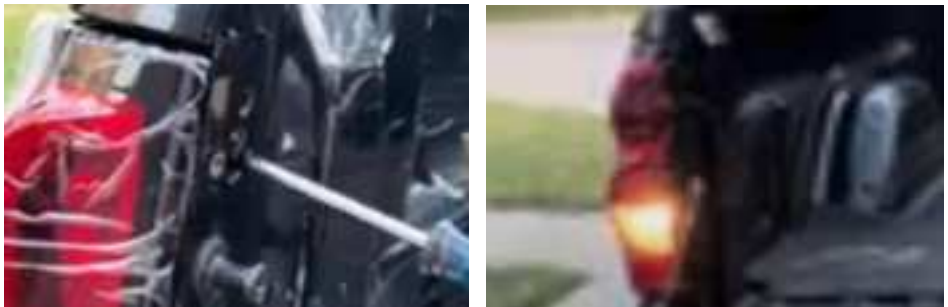
**2.Reinstall 2 Phillips screws and test our light make sure everything works as it should.**

**※The above figure shows the replacement of only one of the models, the operation process is similar for other models.**
