swift 502BHSP 4 Burner Cooktop Instruction Manual

GAS SAFETY RECALL

PRA 2022/19498 – Swift Appliance Group 500 Series Cooker/Grill and Cooktops

Model Numbers 502BHSP, 502BHFW, 502DHSP, 502RHSP, 502SHFW, 502SHW, 502WBHSP, 503BHSPM, 503BHSP, 503BHSPMLG, 503BHSW, 503DHSP, 503RHSP, 503SHSPM, 503SHSW and 503BHSPN. Approval Number AGA **6488G**

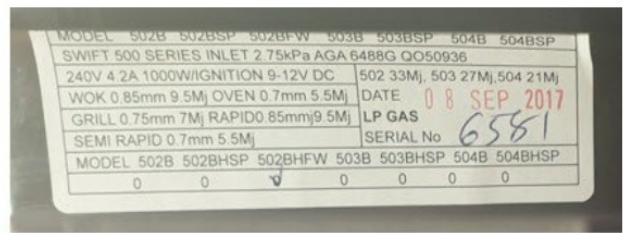
Identification: To identify affected appliances, check the model number on the data plate. Open the glass lid and look for the data plate on the inside front left side of the lid.

Defect: A part of the gas supply pipe in the front left burner may break or develop a hole. This can cause the gas to leak.

1. Turn the front left burner control knob to the off position, remove the knob and store it out of reach of other users.
2. DO NOT USE the front hotplate left burner. The other burners and the electric hotplate can be used.
3. For cookers manufactured between 1 January 2019 and 31 May 2020, contact Swift Appliance Group to have your appliance inspected and repaired if required.
4. If the appliance was manufactured before 1 January 2019 – wait for further information from Swift Appliance Group
